ATLANTIC COAST BASIN
SCOTLAND RUN, GLOUCESTER COUNTY
NEW JERSEY

MALAGA DAM
NJ 00443

PHASE 1 INSPECTION REPORT
NATIONAL DAM SAFETY PROGRAM

February, 1979

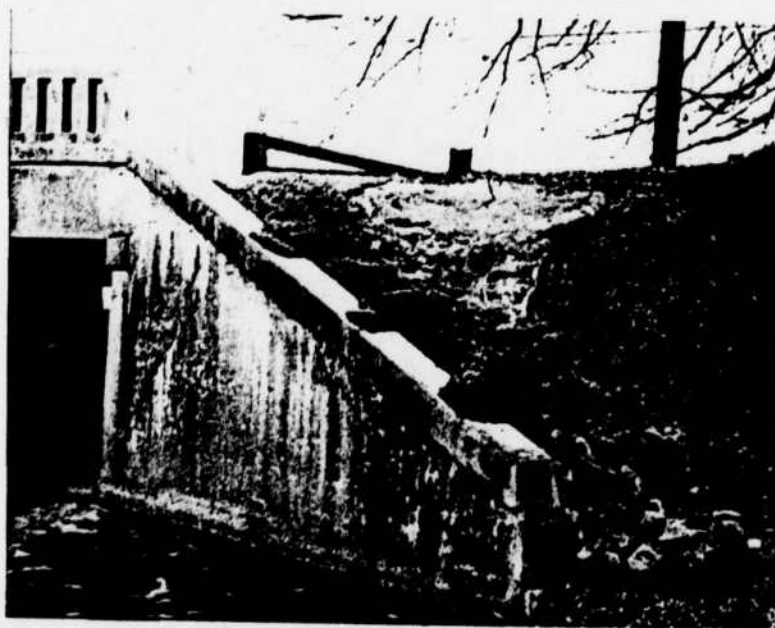
Downstream view of East abutment

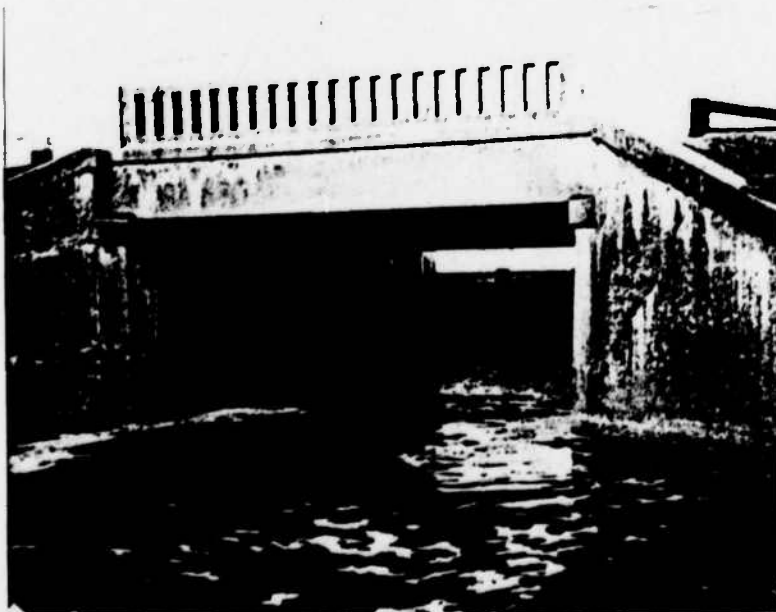
The concrete spillway bridge is in fair condition and the timber flashboards, being constantly submerged appear free of dry rot. However, it would prove difficult to remove them without destroying them. The walls of the bridge abutments and wings are cracked and spalled but are structurally sound insofar as the dam structure is concerned. The tops of the downstream wingwalls are badly cracked and the superstructure soffit is spalled and is undoubtedly in need of replacement or repair. A cursory review of the traffic volume using Route 40 indicates the superstructure should be repaired or more probably, be replaced (if subjected to present FHWA and DOT bridge rating criteria).

Downstream view of bridge and spillway
